Post Mold Remediation Clearance Report

Project Address: 210 Commercial Drive, Taylor, Texas 76574

Prepared for: Translodging Corporation

Date of Final Clearance Report: May 1, 2020

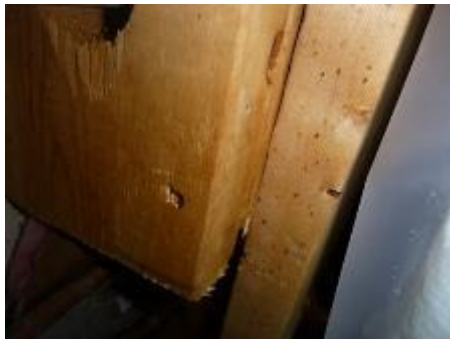
1 - mold like growth

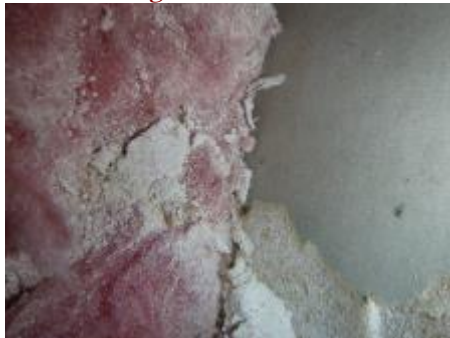
1 - mold like growth

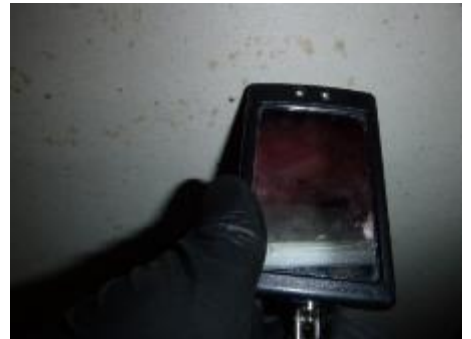
2 - mold like growth

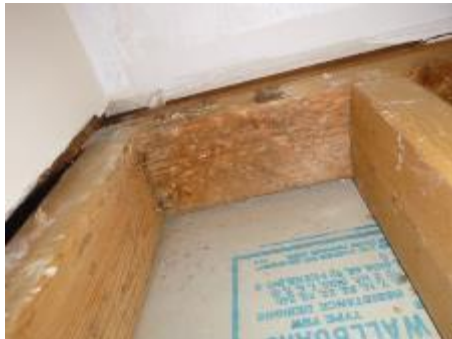
11 - mold like growth

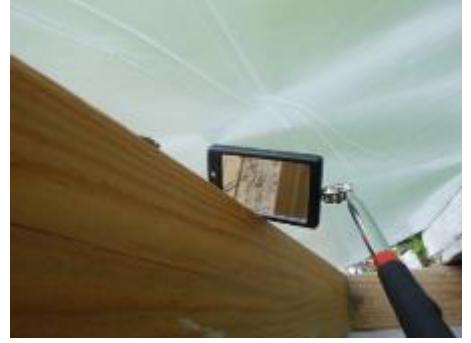
12 - mold like growth

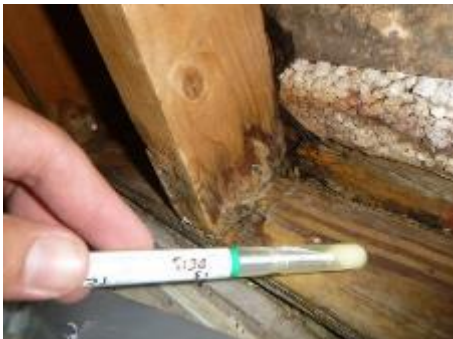
13 - mold like growth and surface sample

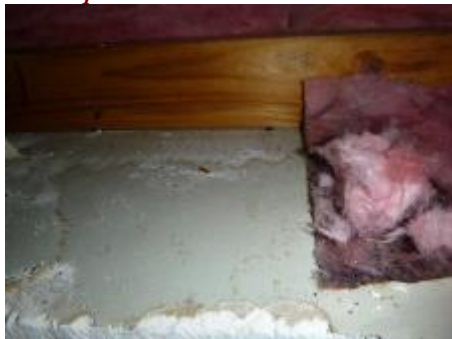
13 - water damage (dry)
