Post Mold Remediation Clearance Report

Project Address: 210 Commercial Drive, Taylor, Texas 76574

Prepared for: Translodging Corporation

Date of Final Clearance Report: May 1, 2020

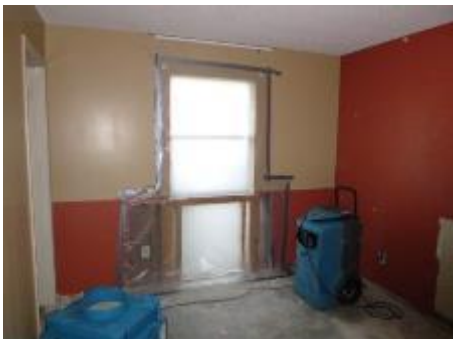
3 - overview

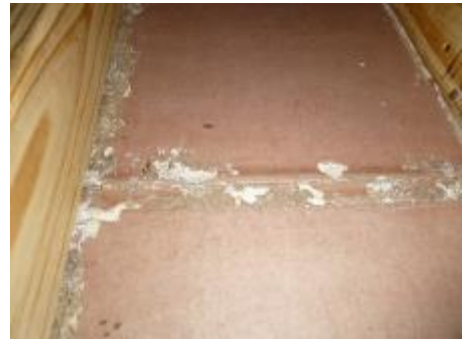
4 - mold like growth

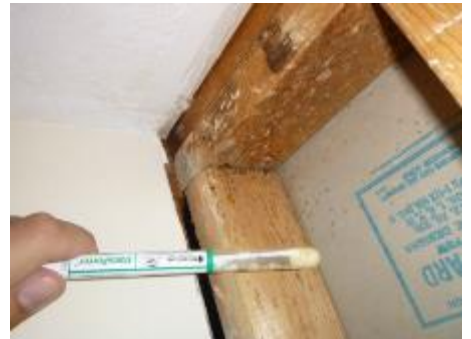
11 - mold like growth

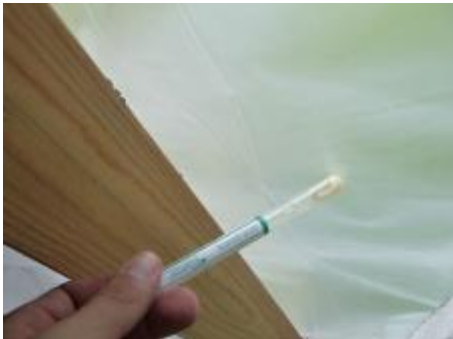
12 - mold like growth
